Predicting subsurface inclusion initiated butterfly-wing cracking under rolling contact fatigue

R. Dai, H. Long

Wind turbine (WT) gearbox bearings experience premature failures. Damage characterisation of failed bearings has shown that subsurface micro cracks and butterfly-wing cracks are associated with non-metallic inclusions in the bearing raceways. The existing studies are unable to predict crack propagation under rolling contact fatigue considering shakedown and ratchetting when the material around an inclusion experiences sufficiently high levels of stresses. In this study, a finite element (FE) damage model based on the Continuum Damage Mechanics (CDM) is developed, integrated with the modelling of plastic deformation and kinematic hardening when the material around inclusion is subjected to alternating tension and compression. Two damage types of manganese-sulphide inclusions are investigated, showing significant effects of inclusion boundary separation and internal cracking on the subsurface RCF crack evolution. The modelling results also show that higher surface traction, overloads and varied loading sequences, commonly experienced by WTs in operation, have significant

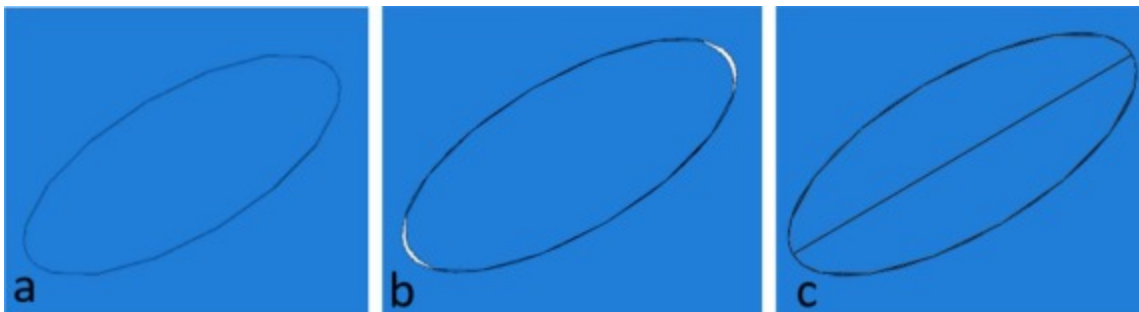
Fig. 4. Definition of the inclusion-steel matrix boundary conditions: (a) Perfectly bonded. (b) Boundary separation. (c) Internal cracked inclusion at 30° .

To investigate the effect of the inclusion damage on RCF crack initiation and propagation, Fig. 4 defines three different types of boundary conditions of the inclusion to the steel matrix by considering both damaged and undamaged inclusions. In Fig. 4(a), the inclusion is perfectly bonded with the steel matrix, and it will not be separated from the matrix during the loading process. Fig. 4(b) shows the separated inclusion with two artificially created gaps at the inclusion tips. In this case, only part of the inclusion boundary is perfectly bonded with the steel matrix. Fig. 4(c) defines an internal crack of the inclusion at 30° to the horizontal contact surface. Apart from the existence of the internal crack, the inclusion is perfectly bonded with the steel matrix, similar to the boundary condition defined in Fig. 4 (a). Because the friction of the MnS is typically small, the contact between two broken parts of the inclusion is defined as a “hard” contact surface and frictionless in the FE model [37].

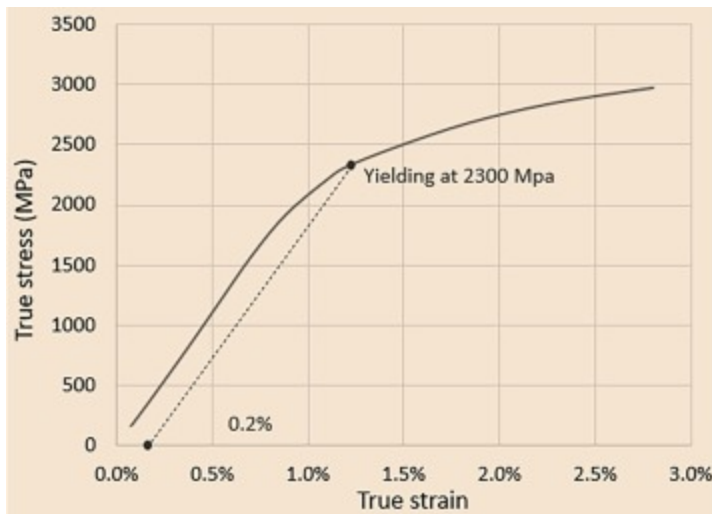
To consider the effect of plastic deformation on the damage evolution, the true stress–strain relationship of the 100Cr6 steel after initial yielding is considered in the study, as shown in

Fig. 6. It can be determined that the initial yielding stress under compression is approximately 2300MPa, the Young's Modulus is 220 GPa, and the Poisson's ratio is 0.3.

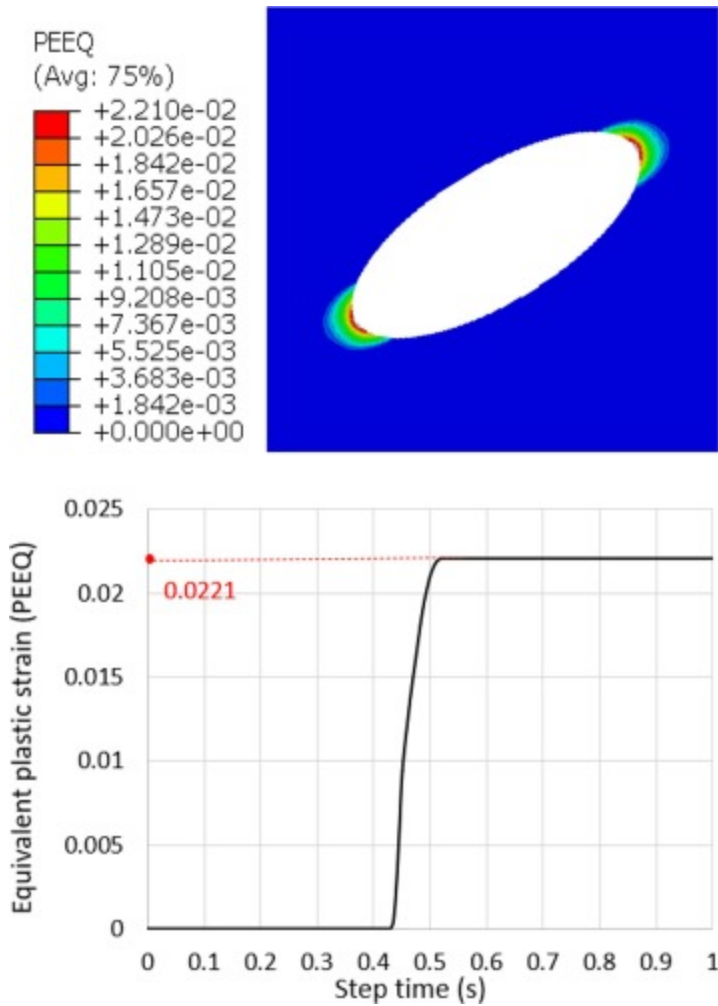
Fig. 8 shows the equivalent plastic strain results of the steel matrix during the first jump-in cycle, when the maximum Hertz contact pressure is defined as a constant value of 2.069 GPa and the inclusion is perfectly bonded with the steel matrix. The results indicate that the steel matrix is subjected to the plastic deformation during the rolling contact process due to the MnS inclusion, and the equivalent plastic deformation reaches 2.21%. In this study, the extreme overloading cases, shown in Table 1, can cause the maximum Hertz contact pressure to increase to 2.84 GPa. Under these extreme conditions, the plastic deformation will accumulate and affect the fatigue resistance of the steel matrix. Therefore, it confirms that the consideration of plastic deformation and the back stress of the material in the damage modelling process is necessary to simulate the shakedown and ratchetting processes of the bearing steel under RCF condition.

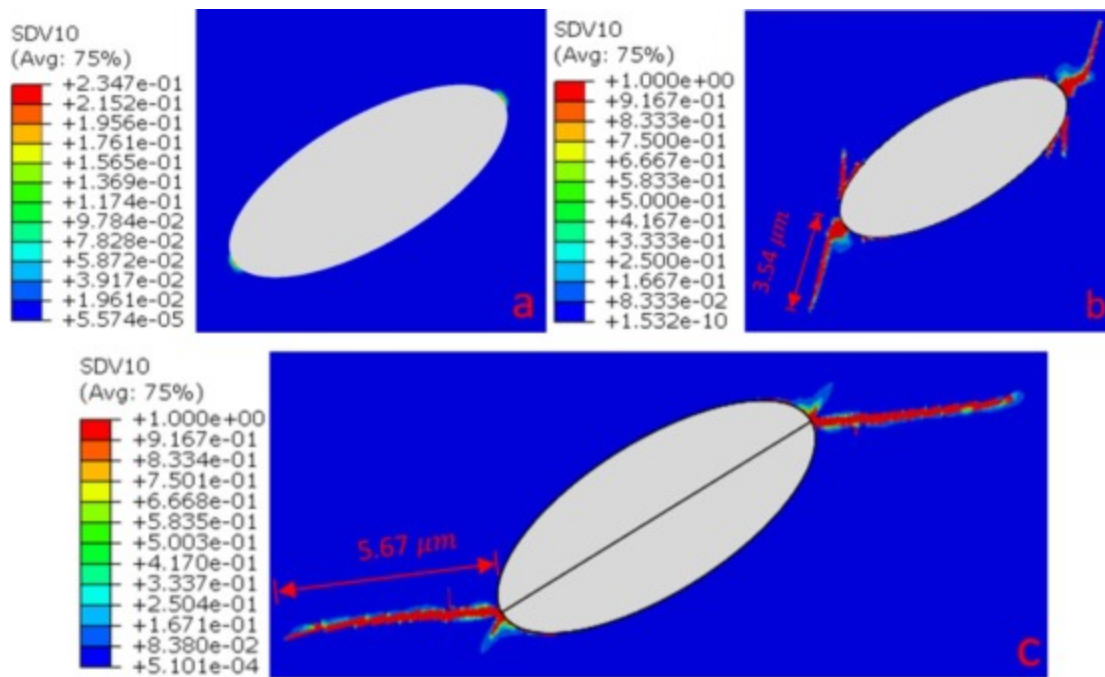
Fig. 9. Conditions of a damaged inclusion on crack propagation: (a) perfectly-bonded inclusion; (b) boundary-separated inclusion; (c) internally-cracked inclusion.

Fig. 9 compares the subsurface RCF damage caused by the MnS inclusion with different boundary conditions. Under the maximum Hertz contact pressure of 2.069 GPa, the maximum traction pressure is 103 MPa when the traction coefficient is 0.05. It can be seen when the inclusion is perfectly bonded with the steel matrix, the accumulated damage D is only 0.235 after 2.0×10^7 loading cycles. This indicates that a perfectly bonded MnS inclusion may not cause great damage to significantly reduce the bearing fatigue life. However, when the inclusion has a separated boundary or an internal crack, the damaged inclusion has cracks propagated to $3.54 \mu\text{m}$ and $5.67 \mu\text{m}$, respectively, as shown in Fig. 9(b) and (c). It is clear that the subsurface RCF crack propagation is greatly influenced by the

condition of the damaged inclusion when it either has the boundary separation or internal cracking.

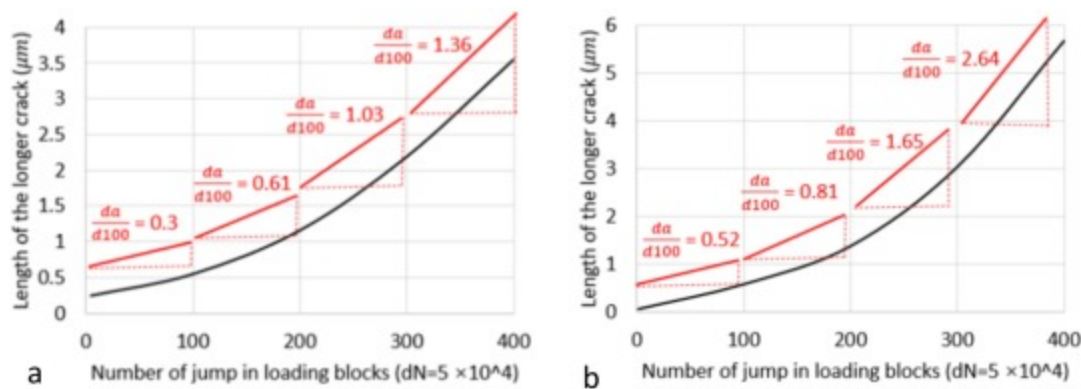
Fig. 11. Crack length vs. jump-in loading cycles: (a) boundary-separated inclusion; (b) internally-cracked inclusion.

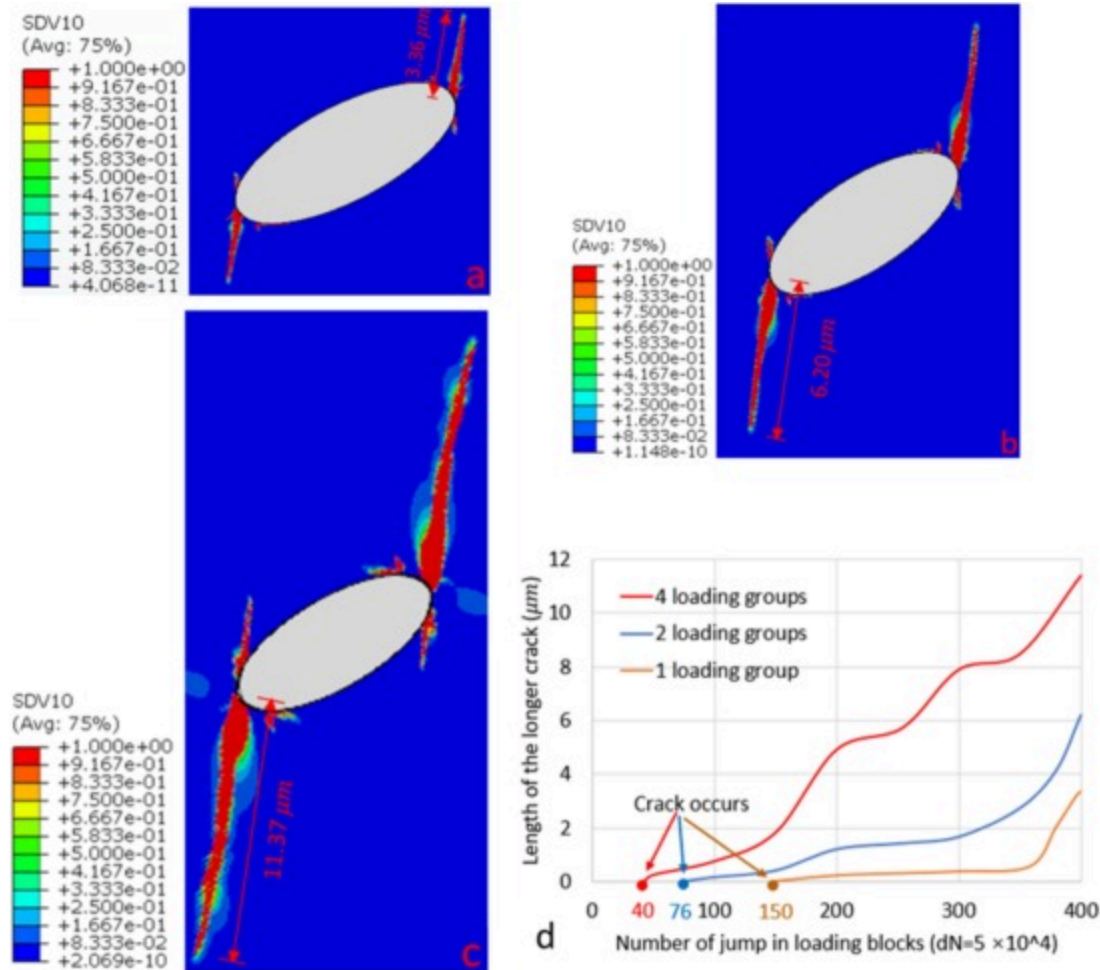
Fig. 13. Evaluation of overloading and extreme loading on crack propagation: (a) 1 loading group; (b) 2 loading groups; (c) 4 loading groups; and (d) comparison of the crack propagation when subjected to 1, 2 and 4 loading groups.

Overloading conditions and wind speed variations are very common in the operation of a wind turbine; the fatigue damage initiated from the subsurface area of bearing raceways is likely to occur much earlier than the ultimate failure of bearings. In addition, according to the IEC 61400 standards, a wind turbine can experience thousands of start-up and shutdown events, even in one year's operation. This makes the bearing overloading occur frequently, which further accelerates the propagation of the RCF crack from the subsurface area to the contact surface of the bearing raceway. To evaluate the effect of overloading and extreme loading conditions, Fig. 13 compares the subsurface RCF damage evolution when a varied number of the loading groups is applied to the CDM FE damage model. The model with four loading groups represents that four times more overloading and extreme loading conditions would occur than that in the model with one loading group. As shown in Fig. 13 (a), 13(b) and 13(c), with the increase of the number of loading groups, the propagated RCF crack length increases significantly from $3.36 \mu\text{m}$ to $11.37 \mu\text{m}$. The relationship between the crack length and the jump-in loading cycles is shown in Fig. 13(d). Due to the variation of

the maximum Hertz contact pressure from 0.92 GPa to 2.83 GPa in each loading group, cracks in all three CDM FE damage models show the wave-like increasing trends. This is because if the overloading and extreme loading conditions occur earlier in the loading process, cracks initiate earlier from the inclusion and has a longer propagation time to reach the contact surface thus significantly accelerating the damage development.

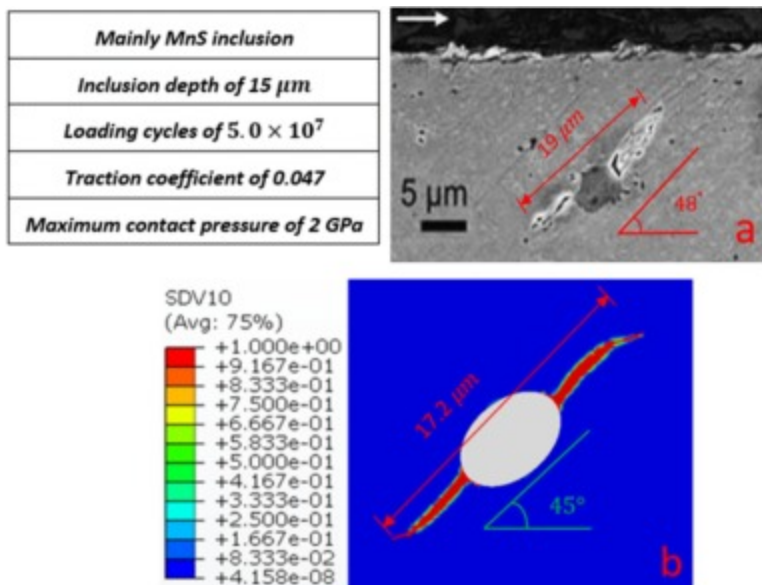
Fig. 14. Comparison of butterfly-wing cracks initiated from MnS inclusion: (a) microscopy image of the inclusion damage from the experiment in [11] (with permission); (b) simulated damage by the developed CDM FE model.

cracks. Fig. 14(a) shows a $\text{MnS} + \text{Al}_2\text{O}_3$ compound inclusion observed in a damaged 100Cr6 specimen obtained from the twin-disc tests in [11]. Because the inclusion is mostly composed of MnS, for the simplification it is considered as the MnS inclusion in the FE damage modelling. As shown in Fig. 9(a), it has been observed that the perfectly bonded inclusion may not lead to the initiation of cracks in the steel matrix within limited loading cycles. Therefore, although a separated boundary is not visible in Fig. 14(a), it has been assumed that the inclusion and the steel matrix are freely contacted with each other without defining any cohesive behaviour in the FE damage modelling. Using the same testing data in the experiment from [11], the number of overall loading cycles of the CDM FE model is defined as 5×10^7 , the maximum contact pressure is 2 GPa, and the traction coefficient is 0.047. Fig. 14(b) shows the simulated crack propagation from the inclusion. The overall length of the butterfly wing cracks modelled is $17.2 \mu\text{m}$; while the actual butterfly damage observed from the microscopy is approximately $19 \mu\text{m}$. The average angle of two propagated butterfly wing cracks from the FE modelling is 45° , as shown in Fig. 14(b), which is similar to the measured angle of 48° in the microscope image [16]. The modelling results are very close to the actual crack propagation.

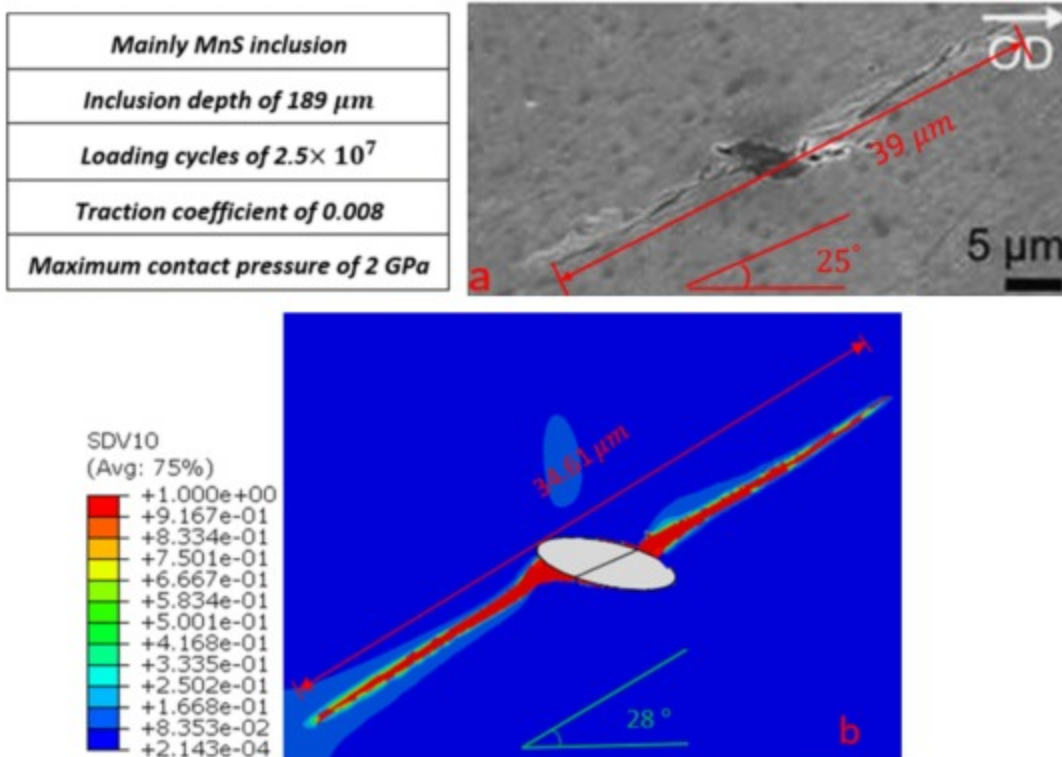
Fig. 16. Comparison of butterfly-wing cracks from an internally cracked MnS inclusion: (a) microscopy image of the inclusion damage from experiment in [11] (with permission); (b) simulated damage by the CDM FE model.

As shown in Fig. 16(a), the butterfly-wing cracks, also from the experimental tested specimens in [11], are initiated by a MnS inclusion containing an internal crack. To model an internally cracked inclusion, the interface between the inclusion and the steel matrix is

defined as perfectly bonded. Using the same testing data in the experiment from [11], the overall loading cycles simulated is 2.5×10^7 , the maximum contact pressure is 2 GPa, and the traction coefficient is 0.002. The modelling result of the butterfly-wing cracks is shown in Fig. 16(b). It can be seen that the modelled propagation angle of the cracks is 28° and the measured angle from the experimental tested specimen is 25° . The butterfly-wing cracks propagate exactly by following the direction of the internal crack tips of the inclusion. The modelled overall butterfly crack length is $34.61 \mu\text{m}$, which is approximately $4 \mu\text{m}$ shorter than the butterfly crack length of $39 \mu\text{m}$ observed in the experimental tested specimen in [11]. This difference may be caused by the definition of the damage parameter D in the CDM FE model. In this study, the maximum value of D is set as 0.9 to avoid the non-convergence problems in the FE simulations. It means that when the accumulated damage parameter exceeds 1.0, ABAQUS software will compulsively change it to 0.9 for the computation of the next jump-in loading cycle. Therefore, in the FE damage modelling, the stress concentration level at the already propagated crack tips should be lower than the actual situation since the FE elements in the cracked area are still withstanding the stress. Consequently, the crack dominating stress in the FE damage modelling is relatively small at the crack tips, leading to the reduction of the propagated crack length. As the difference is small between the modelled and experimentally measured, the effectiveness of the developed CDM FE model is fully demonstrated.

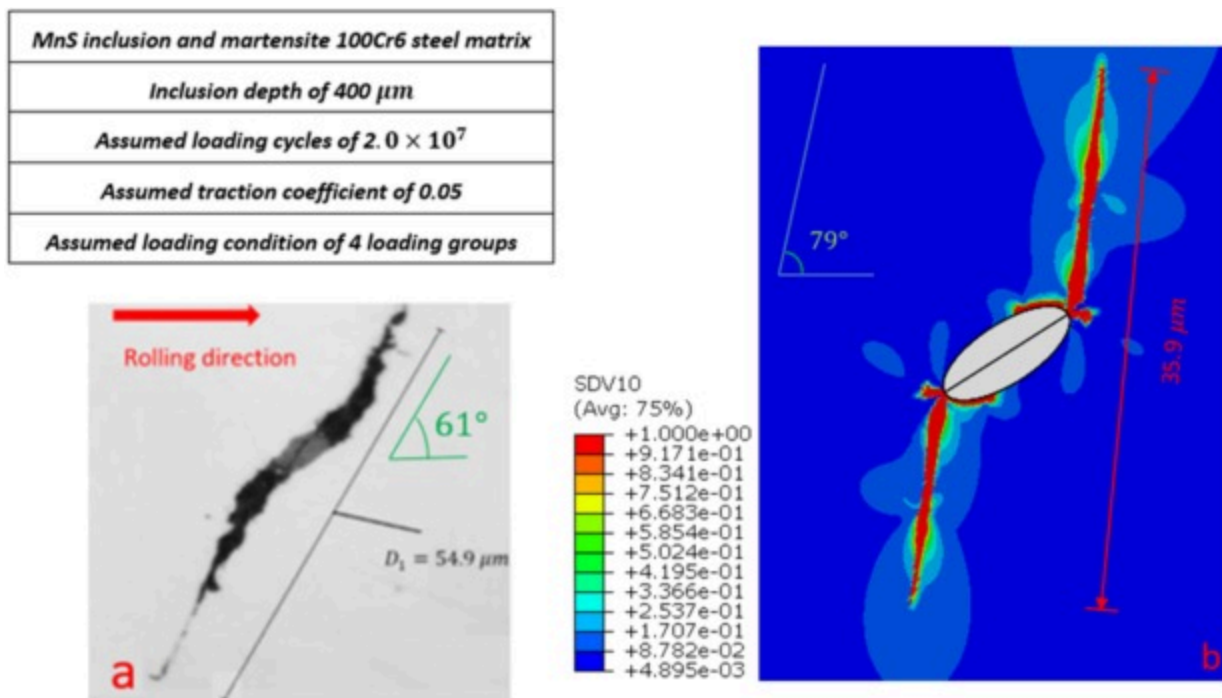
Fig. 17. Comparison of the butterfly-wing cracks from an internally cracked MnS inclusion: (a) damage observed in a failed planetary bearing raceway of the 2MW WT gearbox; (b) simulated damage by the CDM FE model.

To further demonstrate the effectiveness of the developed CDM FE method in investigating the accelerated damage development in the WT application, an internally cracked MnS inclusion with butterfly-wing cracks from a failed planetary bearing raceway of a 2MW WT gearbox in Fig. 1(a), as shown in Fig. 17(a), is used to create the FE damage model. However, the actual loading magnitude and the number of loading cycles experienced by the failed bearing of the WT gearbox in its field operation are not available. Therefore, the overall loading cycle is assumed to be 2×10^7 by employing four varying loading groups assembled from the IEC61400 standards and published studies, as discussed in Section 4.3. The traction coefficient is assumed to be 0.05. As shown in Fig. 17(b), the modelled results of the crack length and propagation angle of the butterfly-wings have some differences with the actual butterfly damage observed from the raceway of the failed bearing. The overall crack length of the butterfly-wings obtained from the CDM FE modelling is $35.9 \mu\text{m}$, much shorter than the actual crack length of $54.9 \mu\text{m}$. Furthermore, the modelled crack propagation angle 79° is considerably greater than the actual propagation angle of 61° .
